2014 KISS Workshop: Gazing at the Solar System

# Imaging for Geotechnical Engineering: Applications to Landslides and Liquefaction

Ellen M. Rathje, Ph.D., P.E.

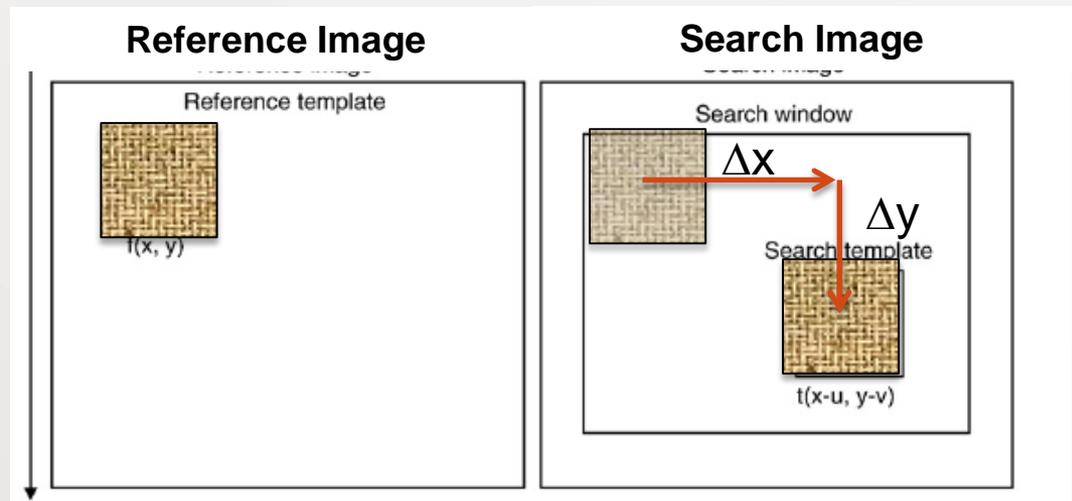
# Image Correlation Analysis

- 0.5-m panchromatic images
- Orthorectification using 30-m SRTM DEM
- Images co-registered using ENVI
- Horizontal correlation performed using COSI-Corr (Leprince et al. 2007)

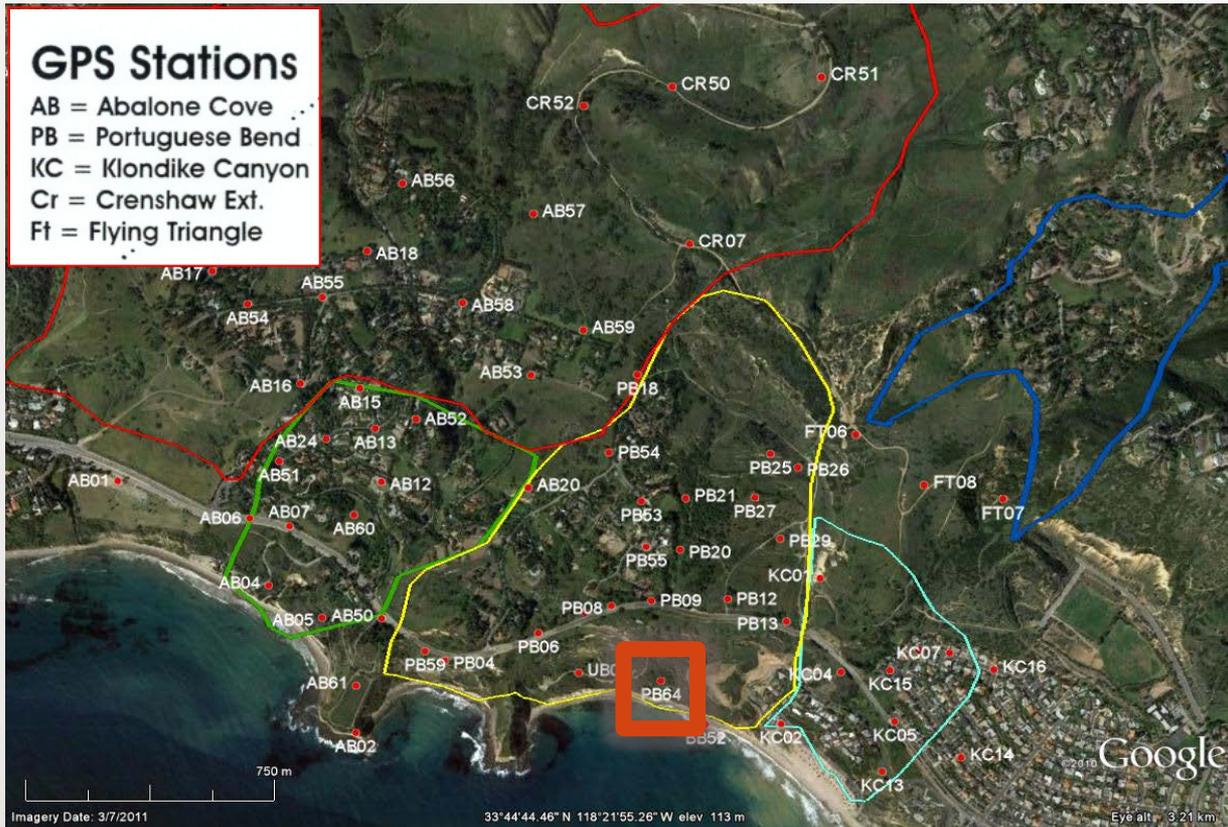
# Portuguese Bend Landslide (PBL)

## *Deformations*

August 2010 – May 2011

GPS Station	Def. (m)	GPS Station	Def. (m)
AB20	0.03	PB21	0.53
BB52	0.02	PB25	0.05
PB04	0.17	PB26	0.04
PB06	0.37	PB27	0.86
PB07	0.45	PB29	0.58
PB08	0.41	PB53	0.44
PB09	0.48	PB54	0.04
PB12	0.83	PB55	0.50
PB13	0.53	PB58	0.25
PB18	0.05	<b>PB64</b>	<b>6.01</b>
PB20	0.73	UB02	1.06

**Rates: 0.5 – 6.0 m/yr**

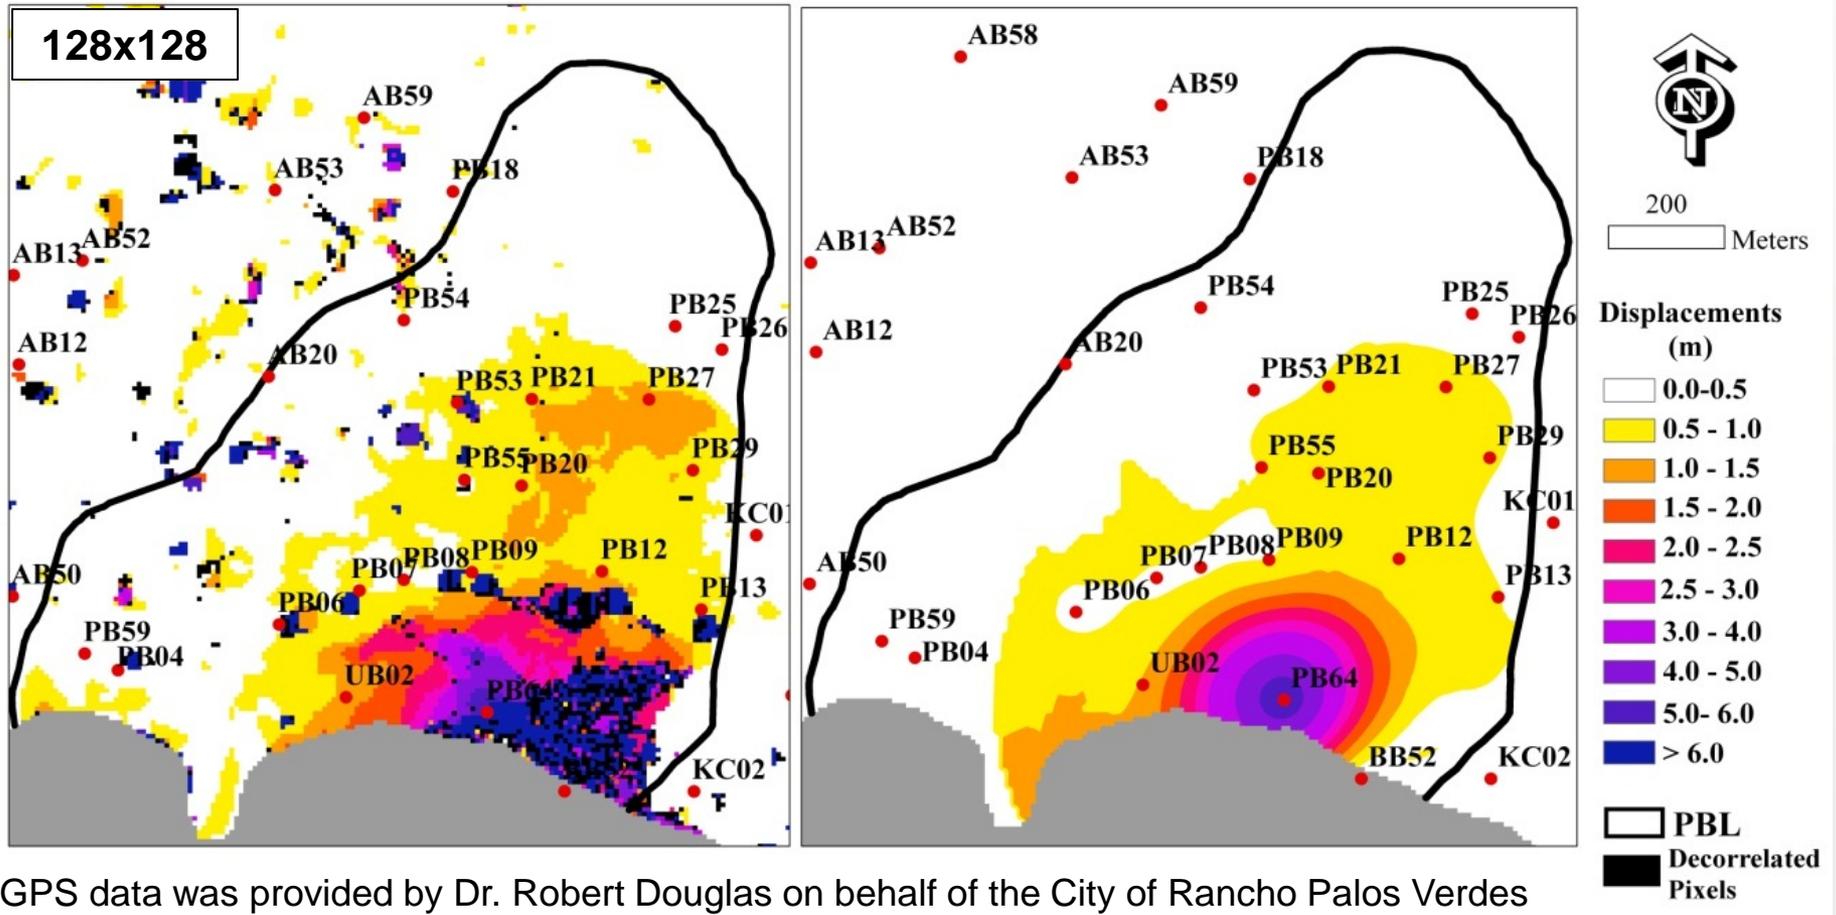
# Comparison with GPS Data

## Optical Image Correlation

## GPS

GPS data was provided by Dr. Robert Douglas on behalf of the City of Rancho Palos Verdes and the Abalone Cove Landslide Abatement District (ACLAD).

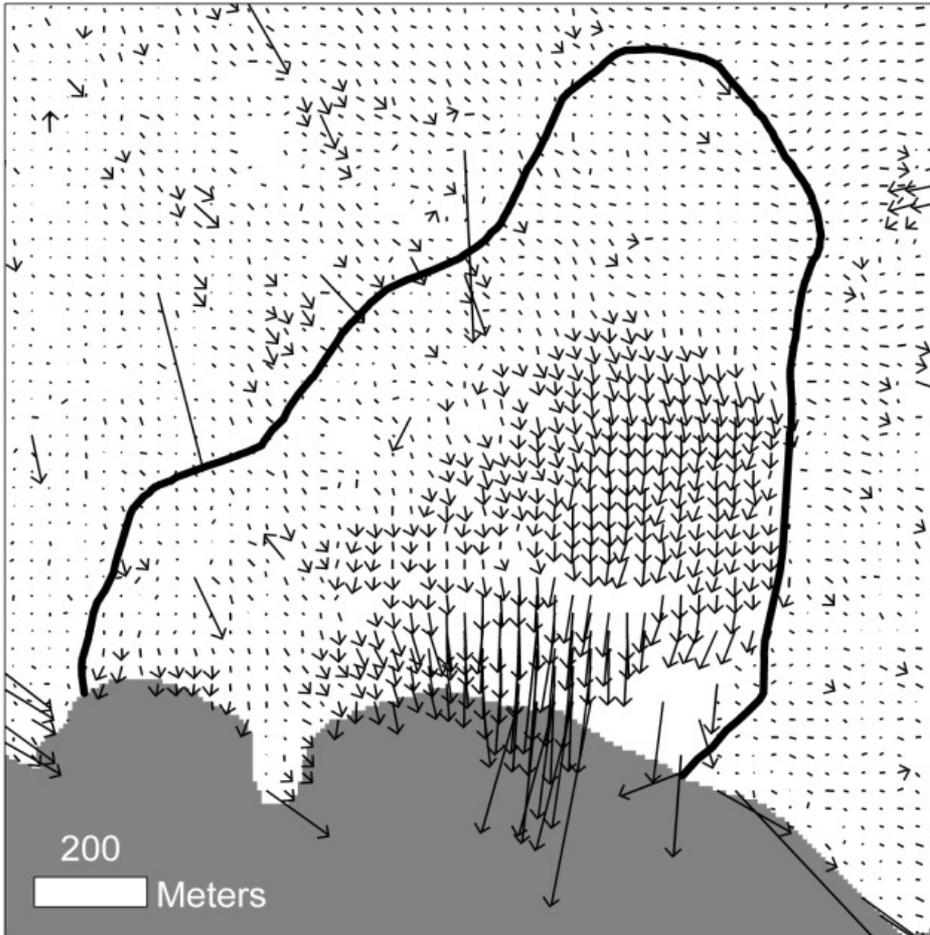
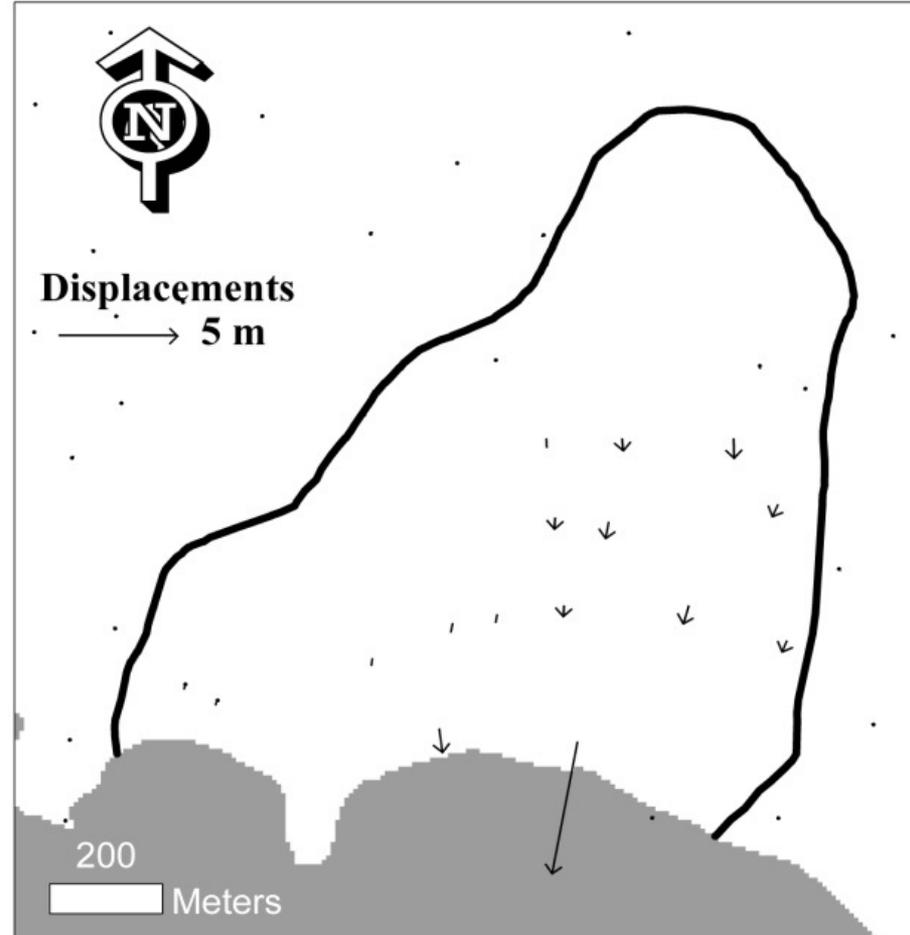
# Deformation Vectors

*Optical Image Correlation*

*GPS*

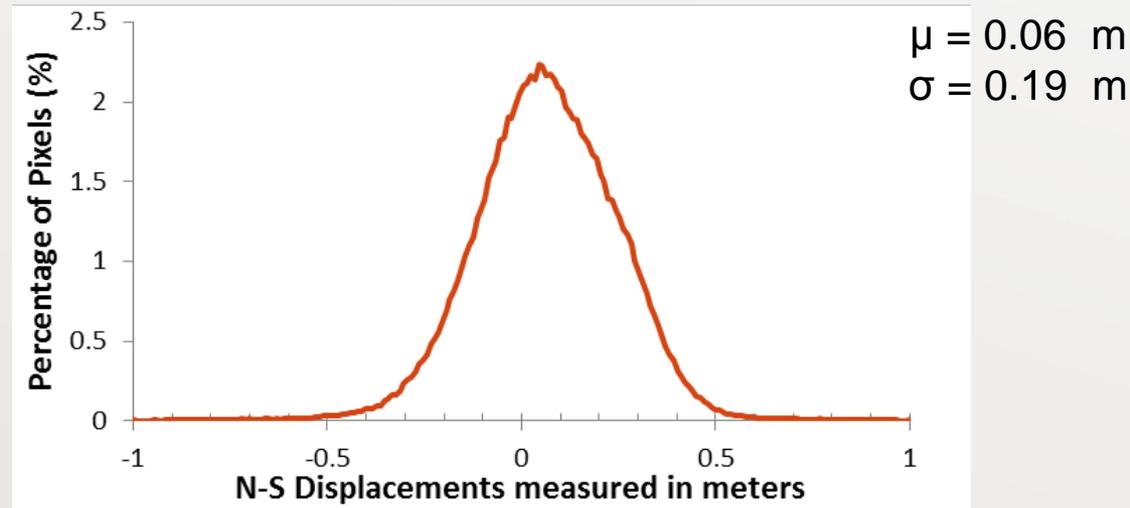
# Smallest Resolvable Displacement

- RMSE for co-registration: ~0.2 pixel (0.1 m)
- Measure displacements outside of the landslide

## *NS Displacements outside landslide zone*

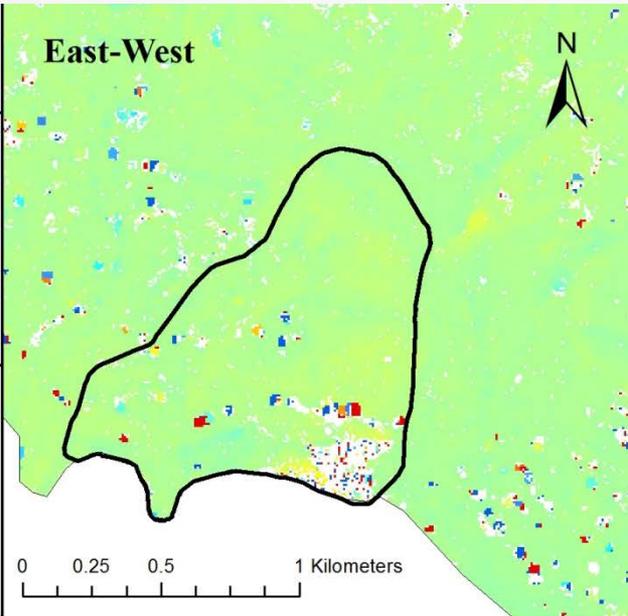
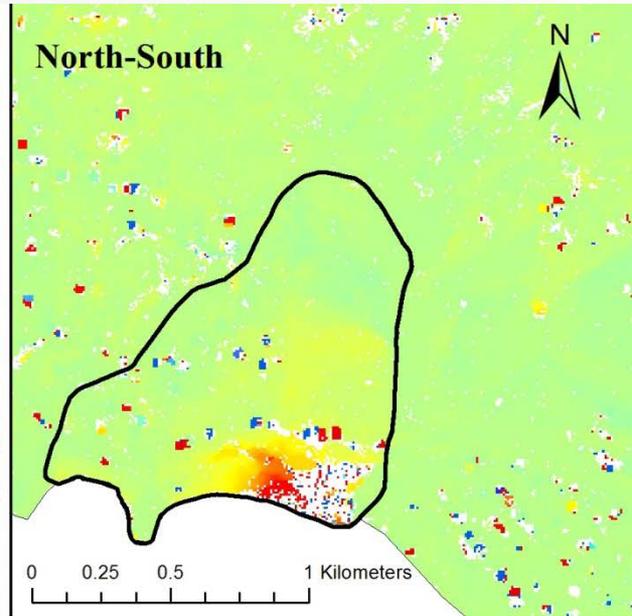
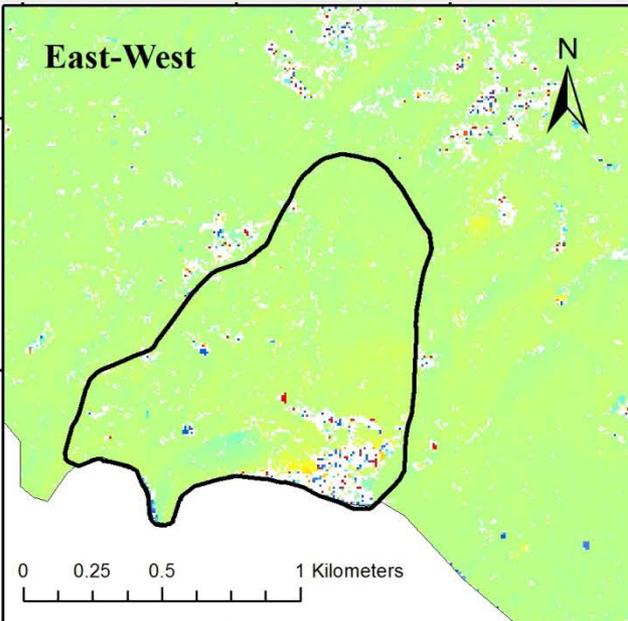
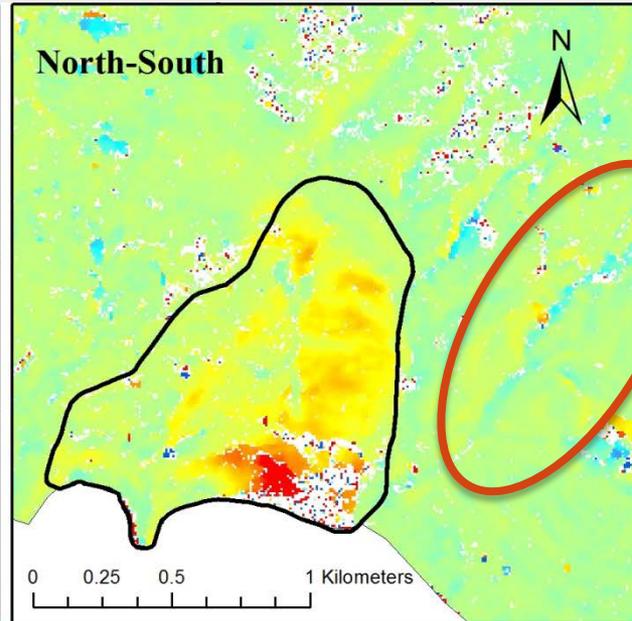
# Influence of Acquisition Geometry

## 4 Different Imagery Pairs

Azimuth	Off-Nadir	EW Angle	NS Angle	
Best Pair	96.7	14.7	14.6	-1.8	$\Delta EW \sim 0.0^\circ$
	94.2	14.6	14.6	-1.1	$\Delta NS \sim 0.7^\circ$
Pair 2	9.3	21.9	3.7	21.6	$\Delta EW \sim 0.1^\circ$
	11.7	17.5	3.6	17.2	$\Delta NS \sim 4.5^\circ$
Pair 3	9.3	21.9	3.7	21.6	$\Delta EW \sim 11.1^\circ$
	41.1	21.9	14.8	16.9	$\Delta NS \sim 4.8^\circ$
Pair 4	113.9	12.0	11.0	-4.9	$\Delta EW \sim 7.6^\circ$
	15.8	12.3	3.4	11.9	$\Delta NS \sim 16.8^\circ$

## *Best Pair*

$\Delta EW \sim 0.0^\circ$   
 $\Delta NS \sim 0.7^\circ$

## *Pair 2*

$\Delta EW \sim 0.1^\circ$   
 $\Delta NS \sim 4.5^\circ$

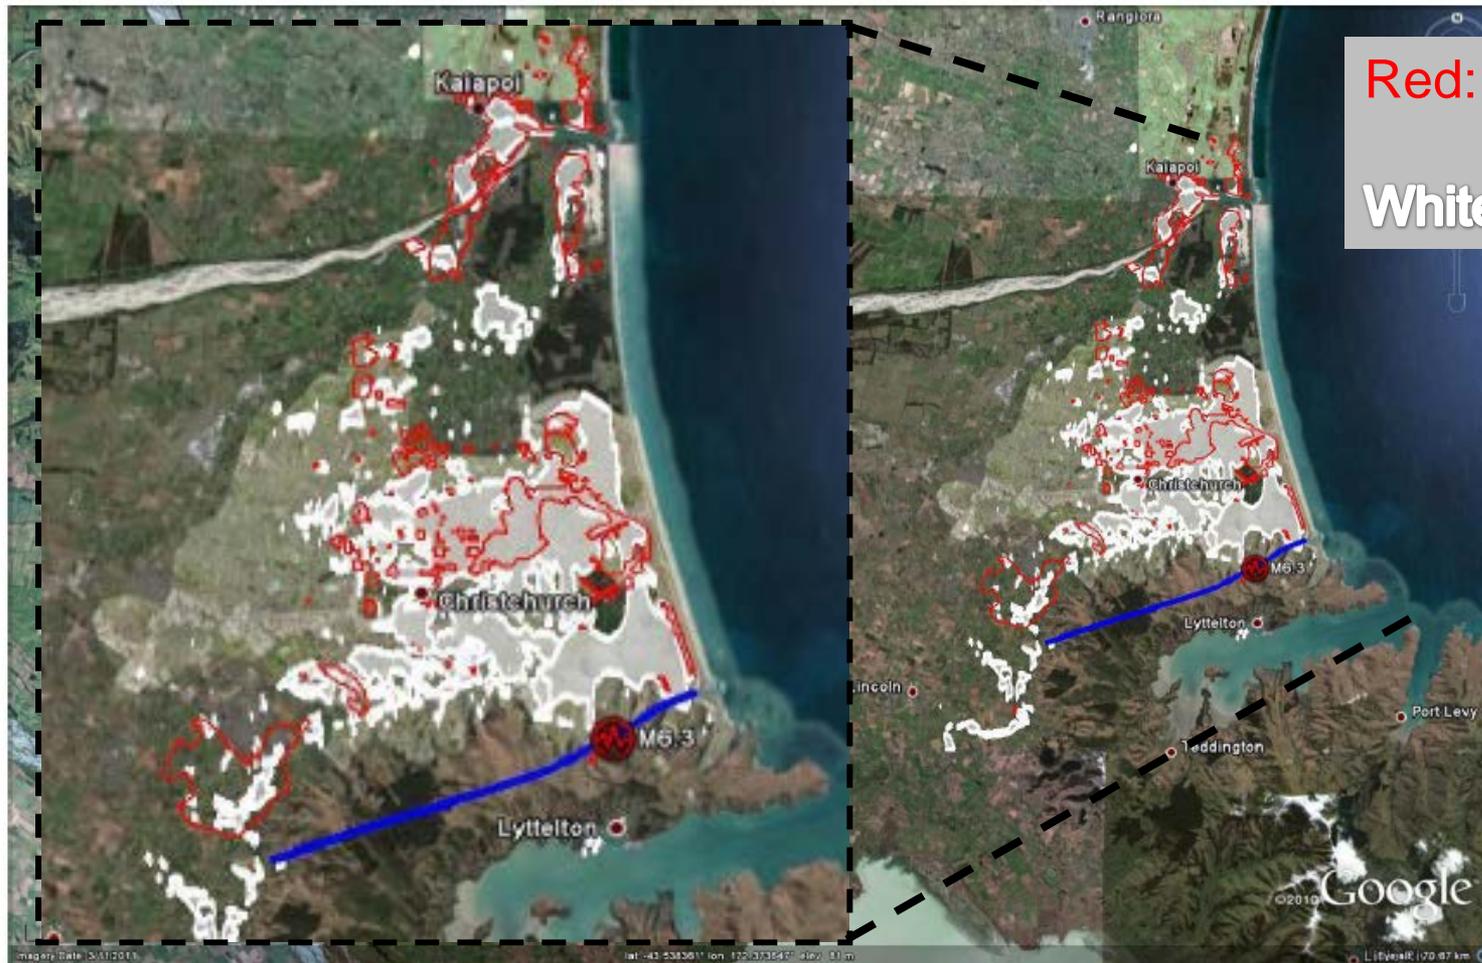
# Observed Liquefaction

**Red:** Darfield EQ

**White:** ChCh EQ

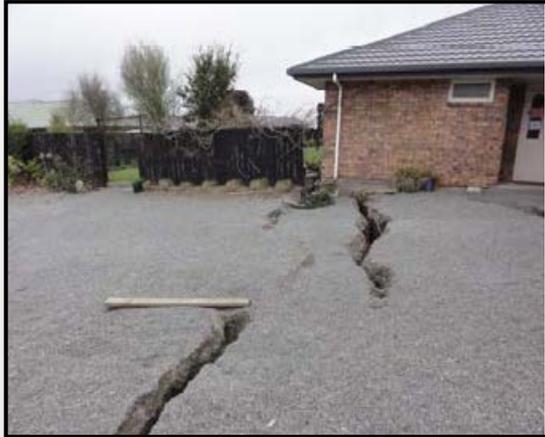
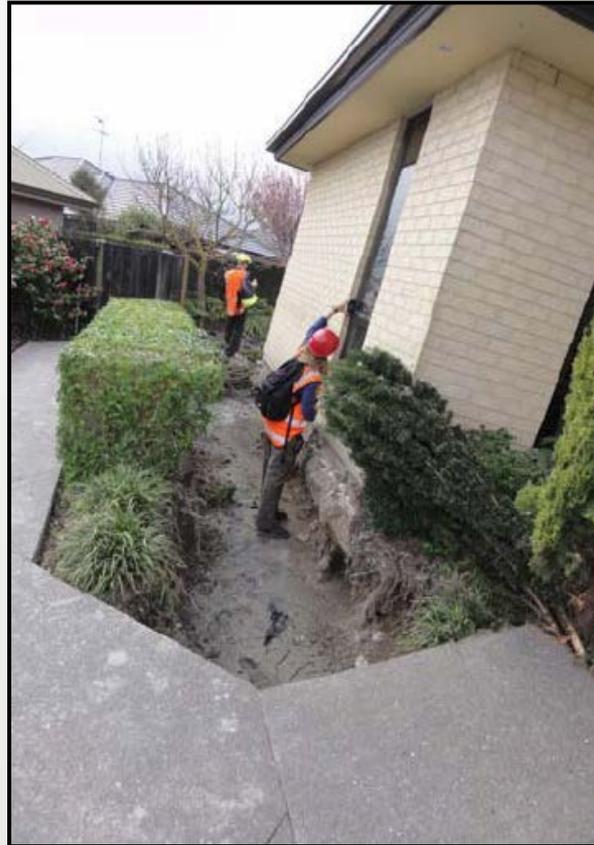
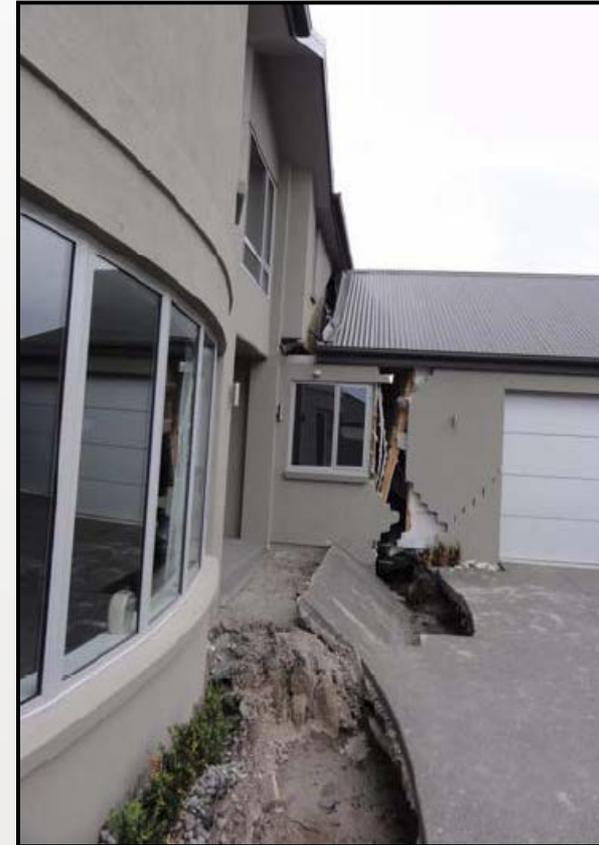
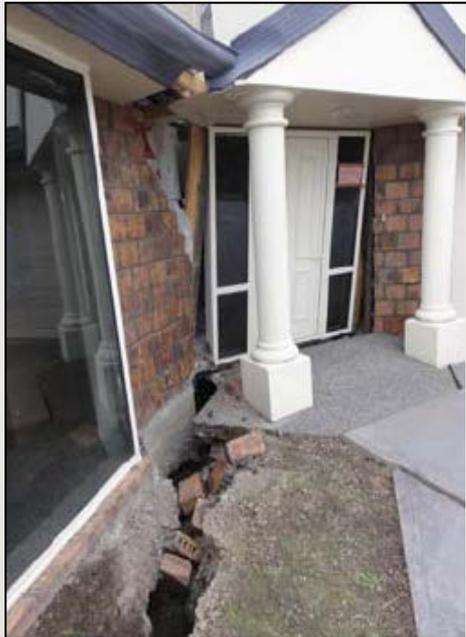
# Observed Liquefaction: ChCh EQ

- ~ 1.5 m wide cracks
- Severe damage to foundations & houses

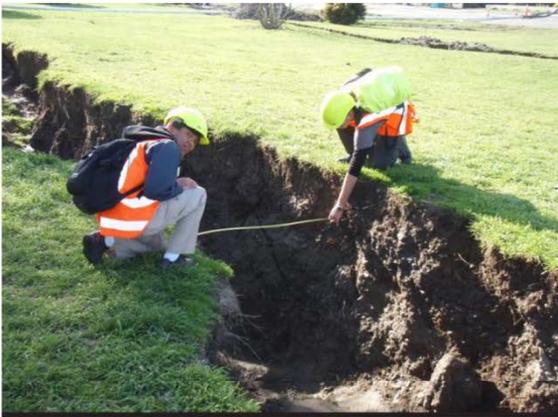
(a) Measuring crack width

***Crack widths are summed  
along a transect to measure  
lateral displacement patterns***

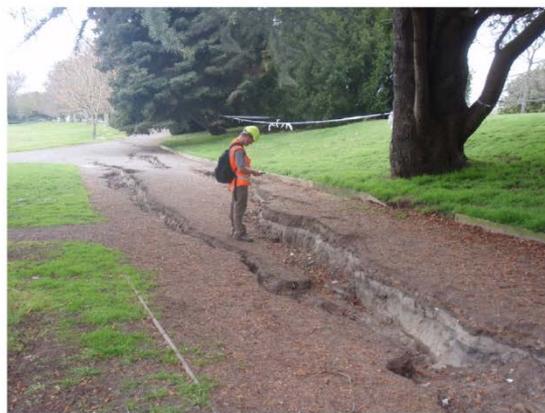
(b) Tracing crack with GPS

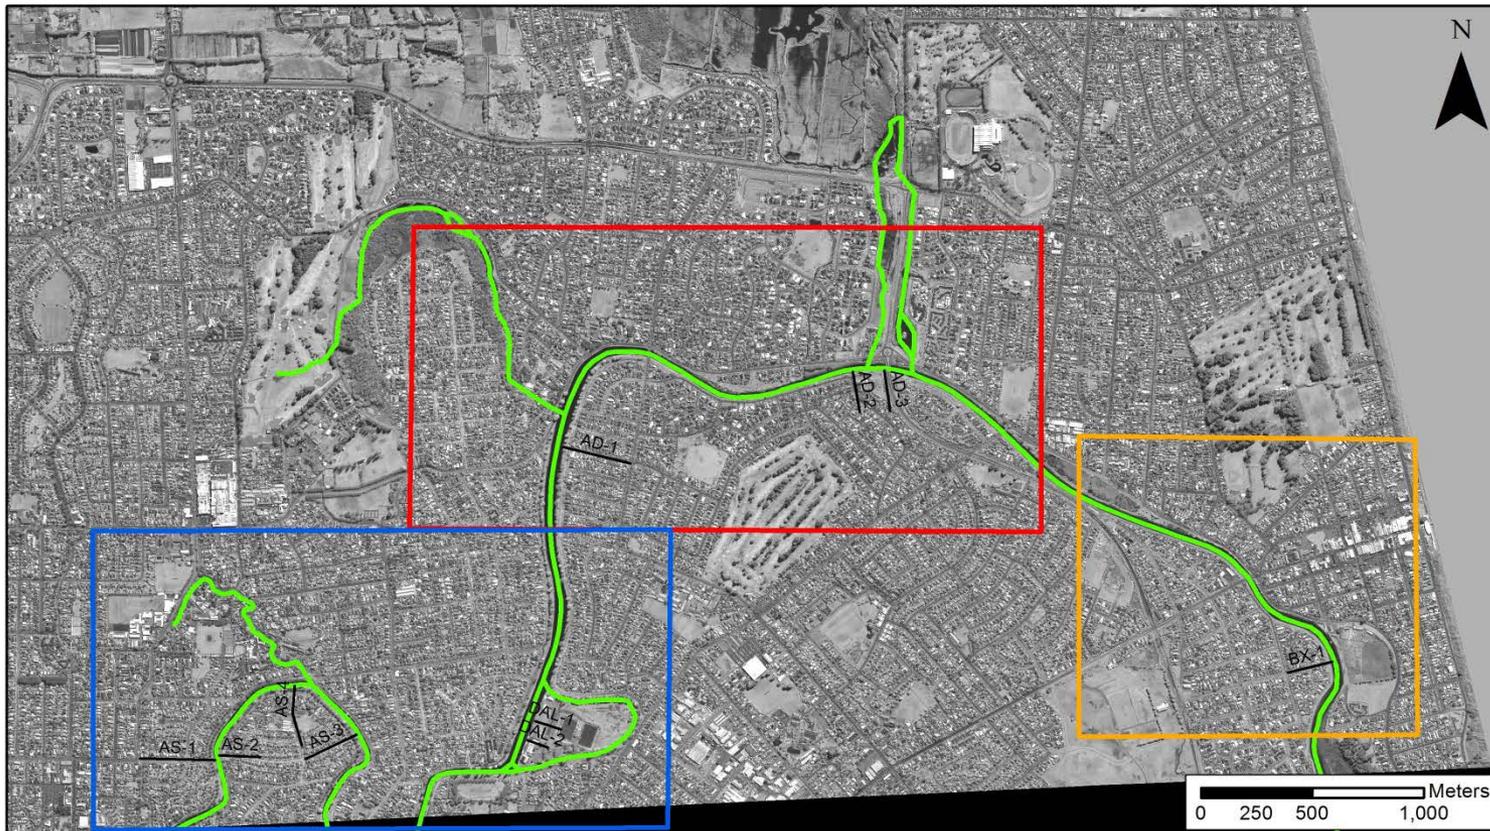
# Christchurch Study Area

0.5-m Pam WV-1/GE-1 images,  $\Delta\text{Off-Nadir} = 1.6^\circ$ ,  $\Delta\text{Az} = 4^\circ$

## Area of Analysis

- Transects
- Avonside
- Avondale
- Bexley
- Avon River

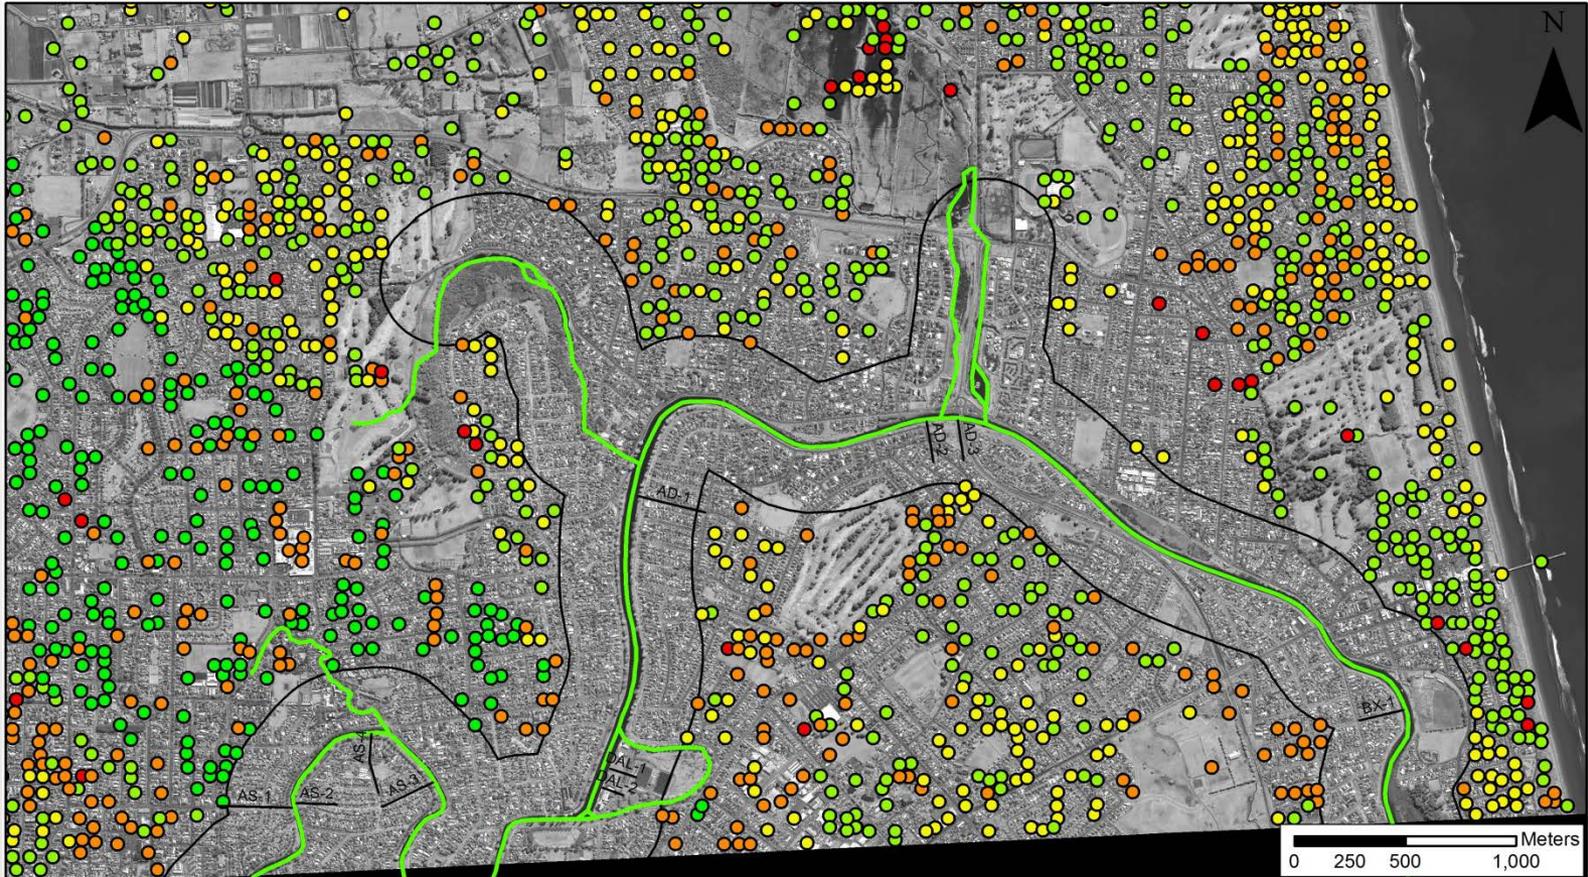
# Tie Points

Tie Point Residuals (m)	
● 0.54 - 0.71	● 0.26 - 0.37
● 0.38 - 0.53	● 0.14 - 0.25
	● 0.00 - 0.13

Overall  
RMSE 0.3 m

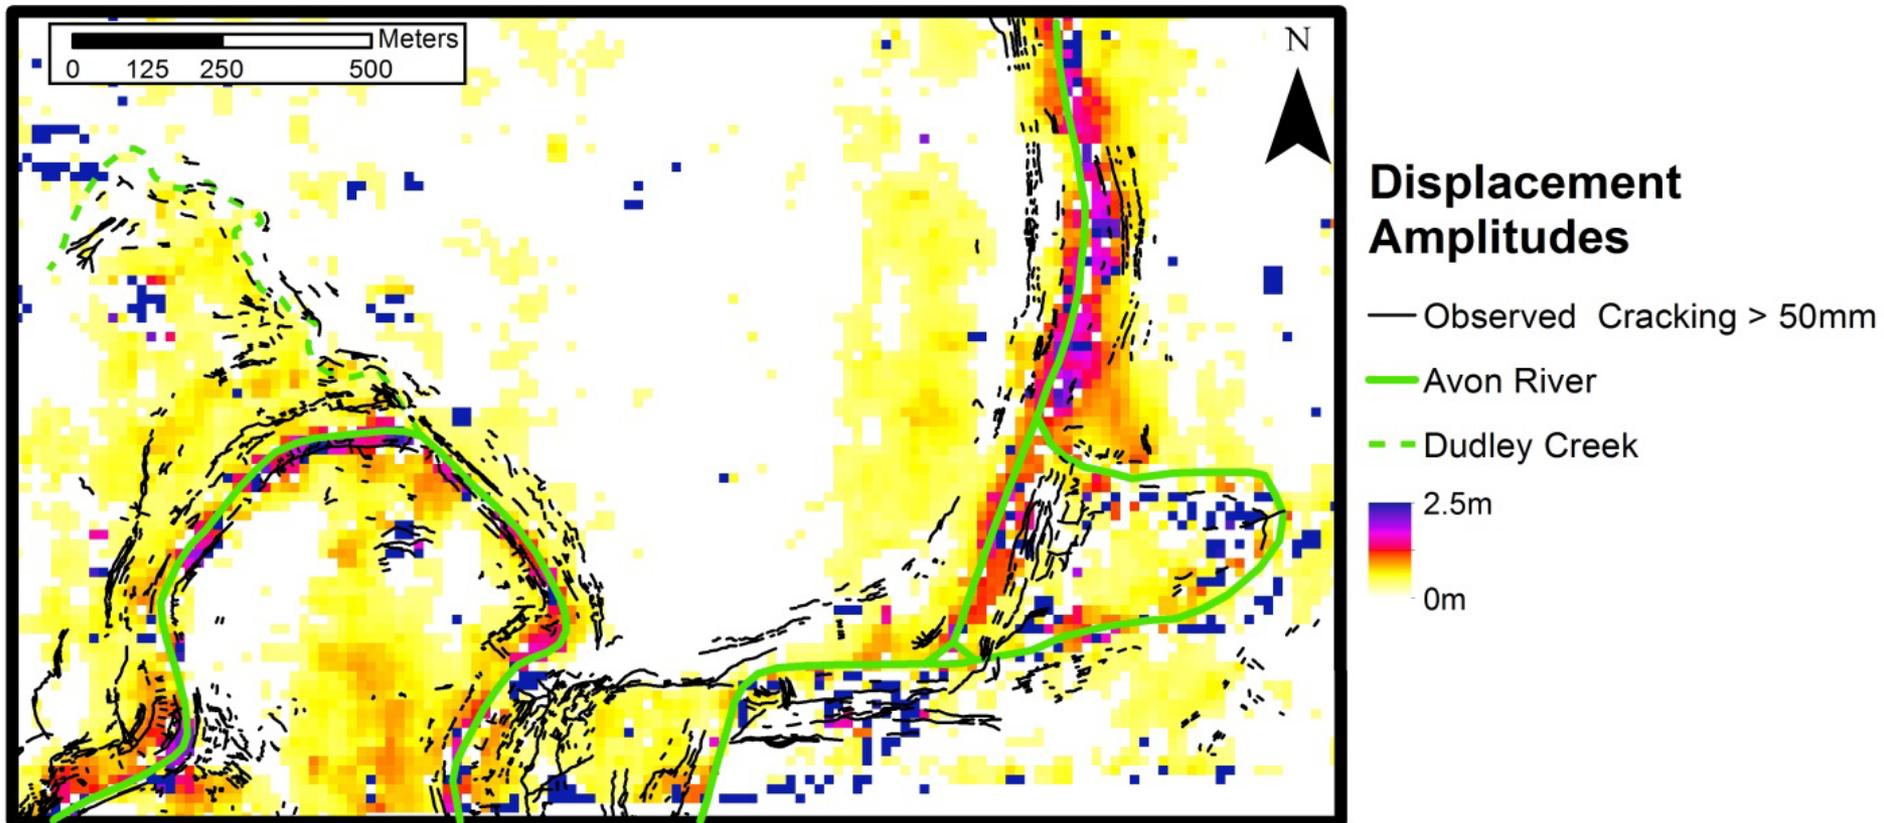
# Avonside

## *Comparison with Observed Cracking*

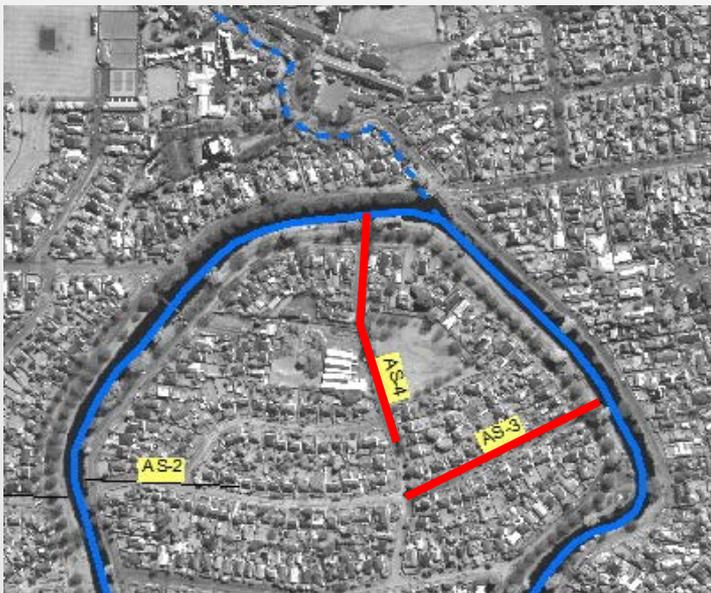
**Transect Locations**

## *Comparison with Displacements from Crack Widths*

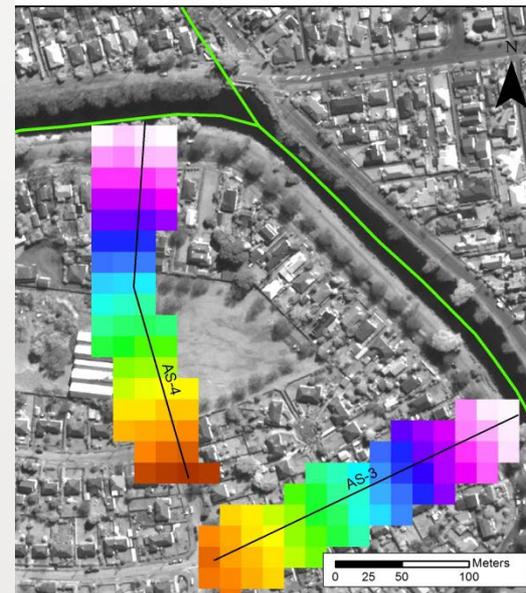
**Transect Averaging**

NS and EW displacements  
rotated to be parallel to the  
transect

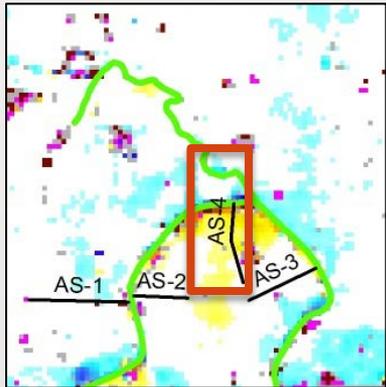
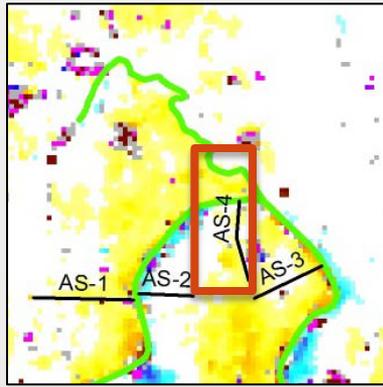
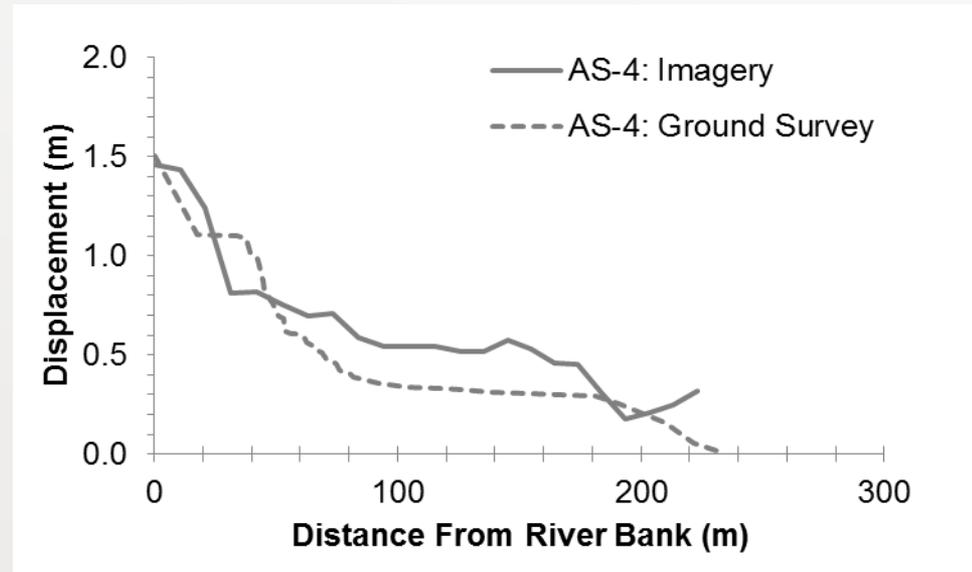
# Avonside: Transects

## *Comparison with Displacements from Crack Widths*

NS Displacements

EW Displacements

Field displacements from Cubrinovski  
(personal communication)

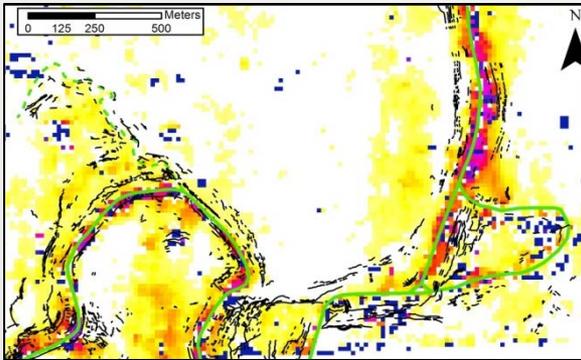
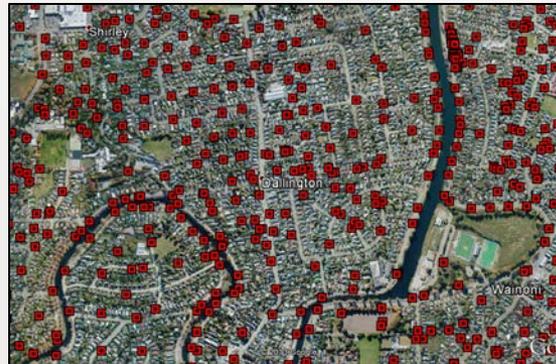
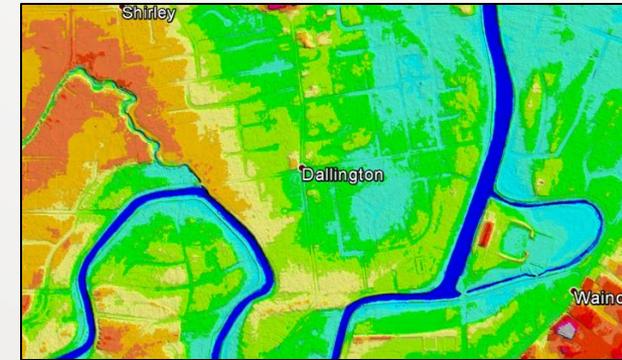
# Now what can we do?

## *Liquefaction: Integration of Deformation, Subsurface, and Topographic Data in Christchurch*

Deformation

Subsurface Characterization

LIDAR DEM

- Liquefaction resistance
- Layering
- Relative density, stiffness
- Soil type
- Lateral Variability

- Slope
- Distance from free-face
- Terrain features
- Geomorphic landforms
